# MANAGEMENT OF TAILINGS STORAGE FACILITIES

Polymetal International plc • JUNE 2021

# Introduction

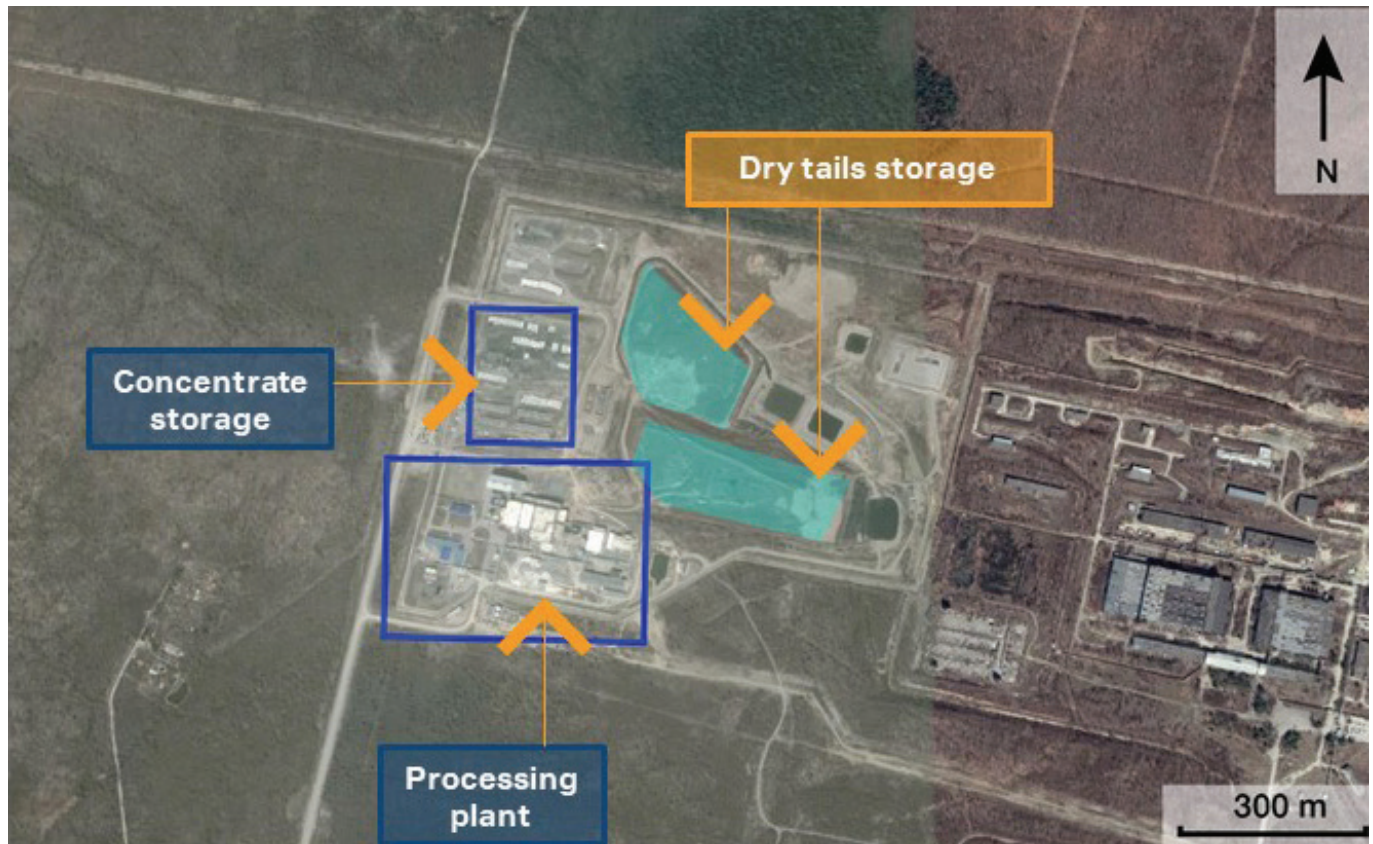
# Amursk DSF location and affected area in case of dam failure

- Safety factor calculated for this type of storages equals 1.20. Adjusted stability factor for the current DSF equals 1.42.
